FINAL REPORT
MARCH 1996

REPORT NO. 96-16

AMMUNITION PECULIAR
EQUIPMENT (APE) 1955
GRENADE FUZE TESTER
MIL-STD-398 TEST

A. BACKGROUND. Due to contamination buildup between the drop tube and the rotary cleanout door and difficulty in opening the rotary cleanout door, the design of the APE 1955 grenade fuze tester was changed. The change resulted in removing the rotary closing cleanout door with a tight-fitting hinged cleanout door. Due to this design change, the fuze tester had to be retested for conformance to MIL-STD-398, Military Standard Shields, Operational for Ammunition Operations, Criteria for Design of and Tests for Acceptance; Method 201, Fragmentation Confinement Tests.

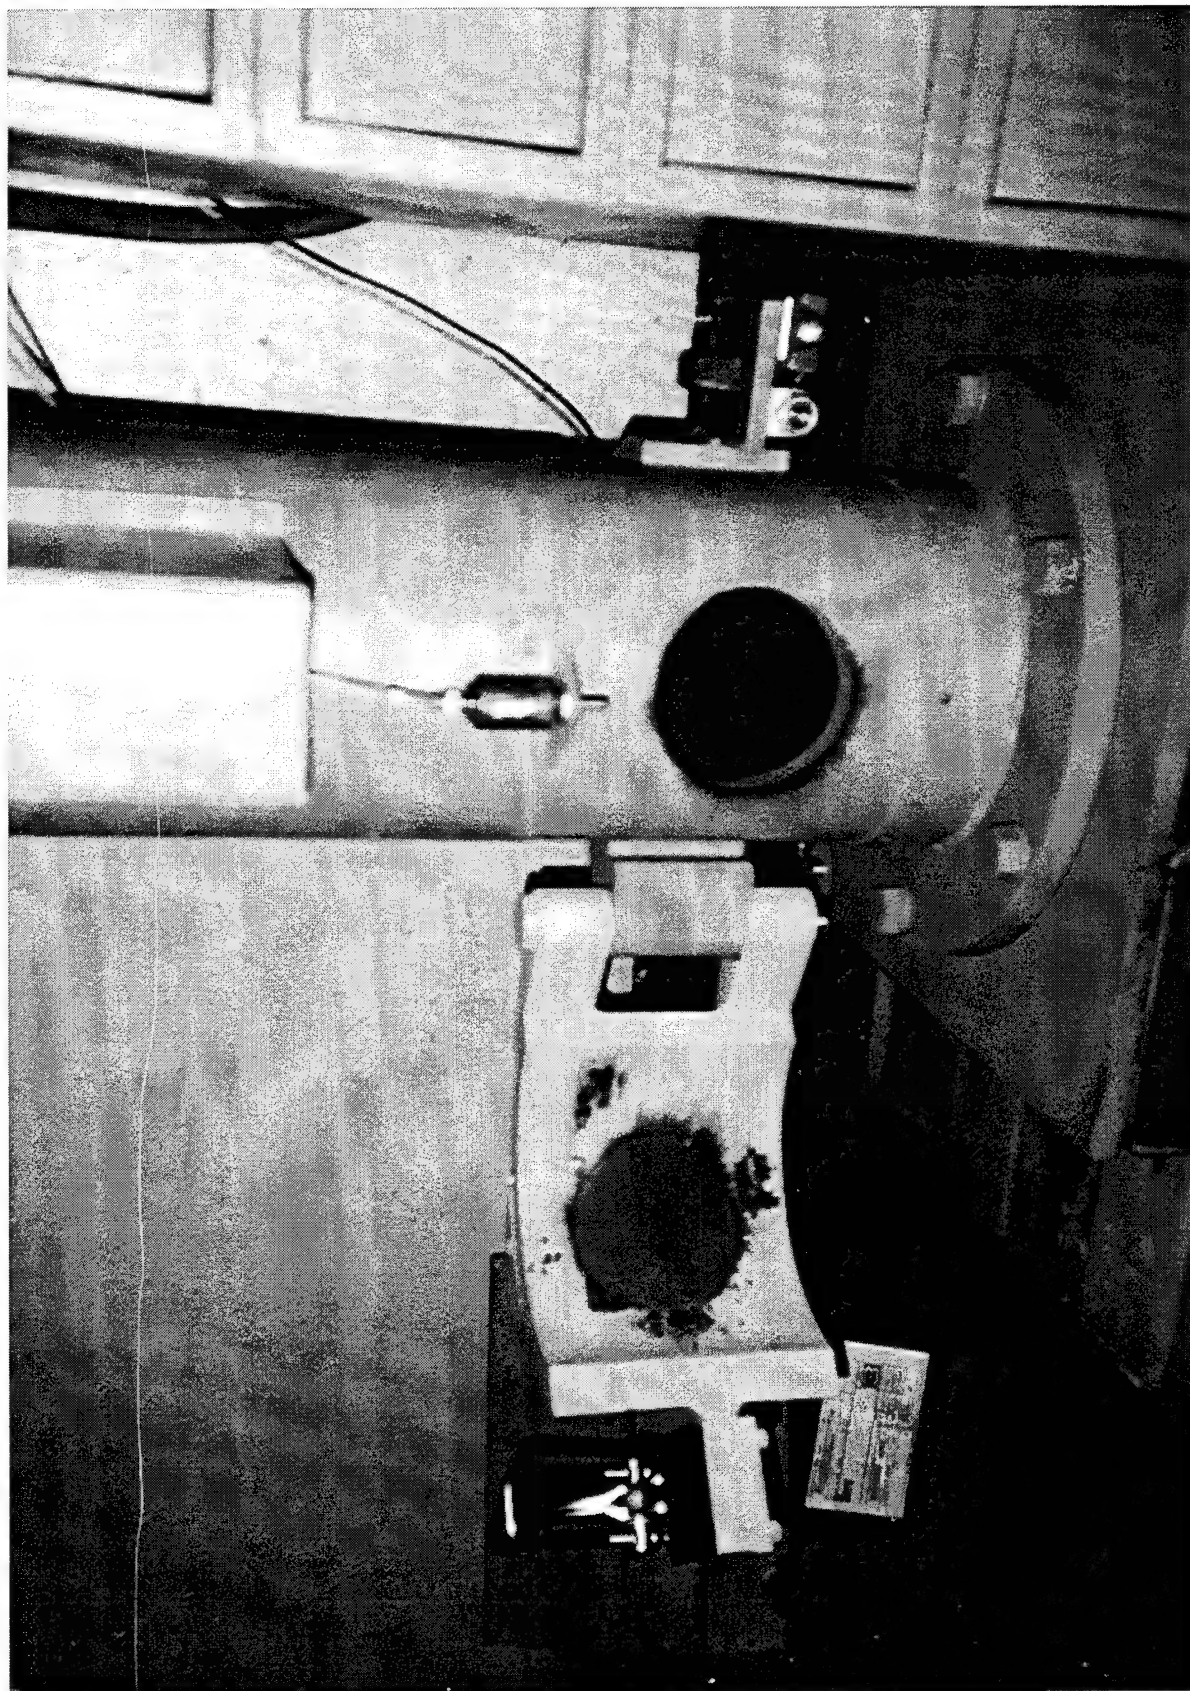
U.S. ARMY DEFENSE AMMUNITION CENTER AND SCHOOL - SAVANNA, IL	
Photo No. USADACS-DEV-96-16-01. This photo shows a closeup view of the APE 1955 modified cleanout door after functioning a grenade fuze. Note smoke residue at the lower left of the cleanout hole and lower right on the door. No schrapnel was found outside the drop tube.

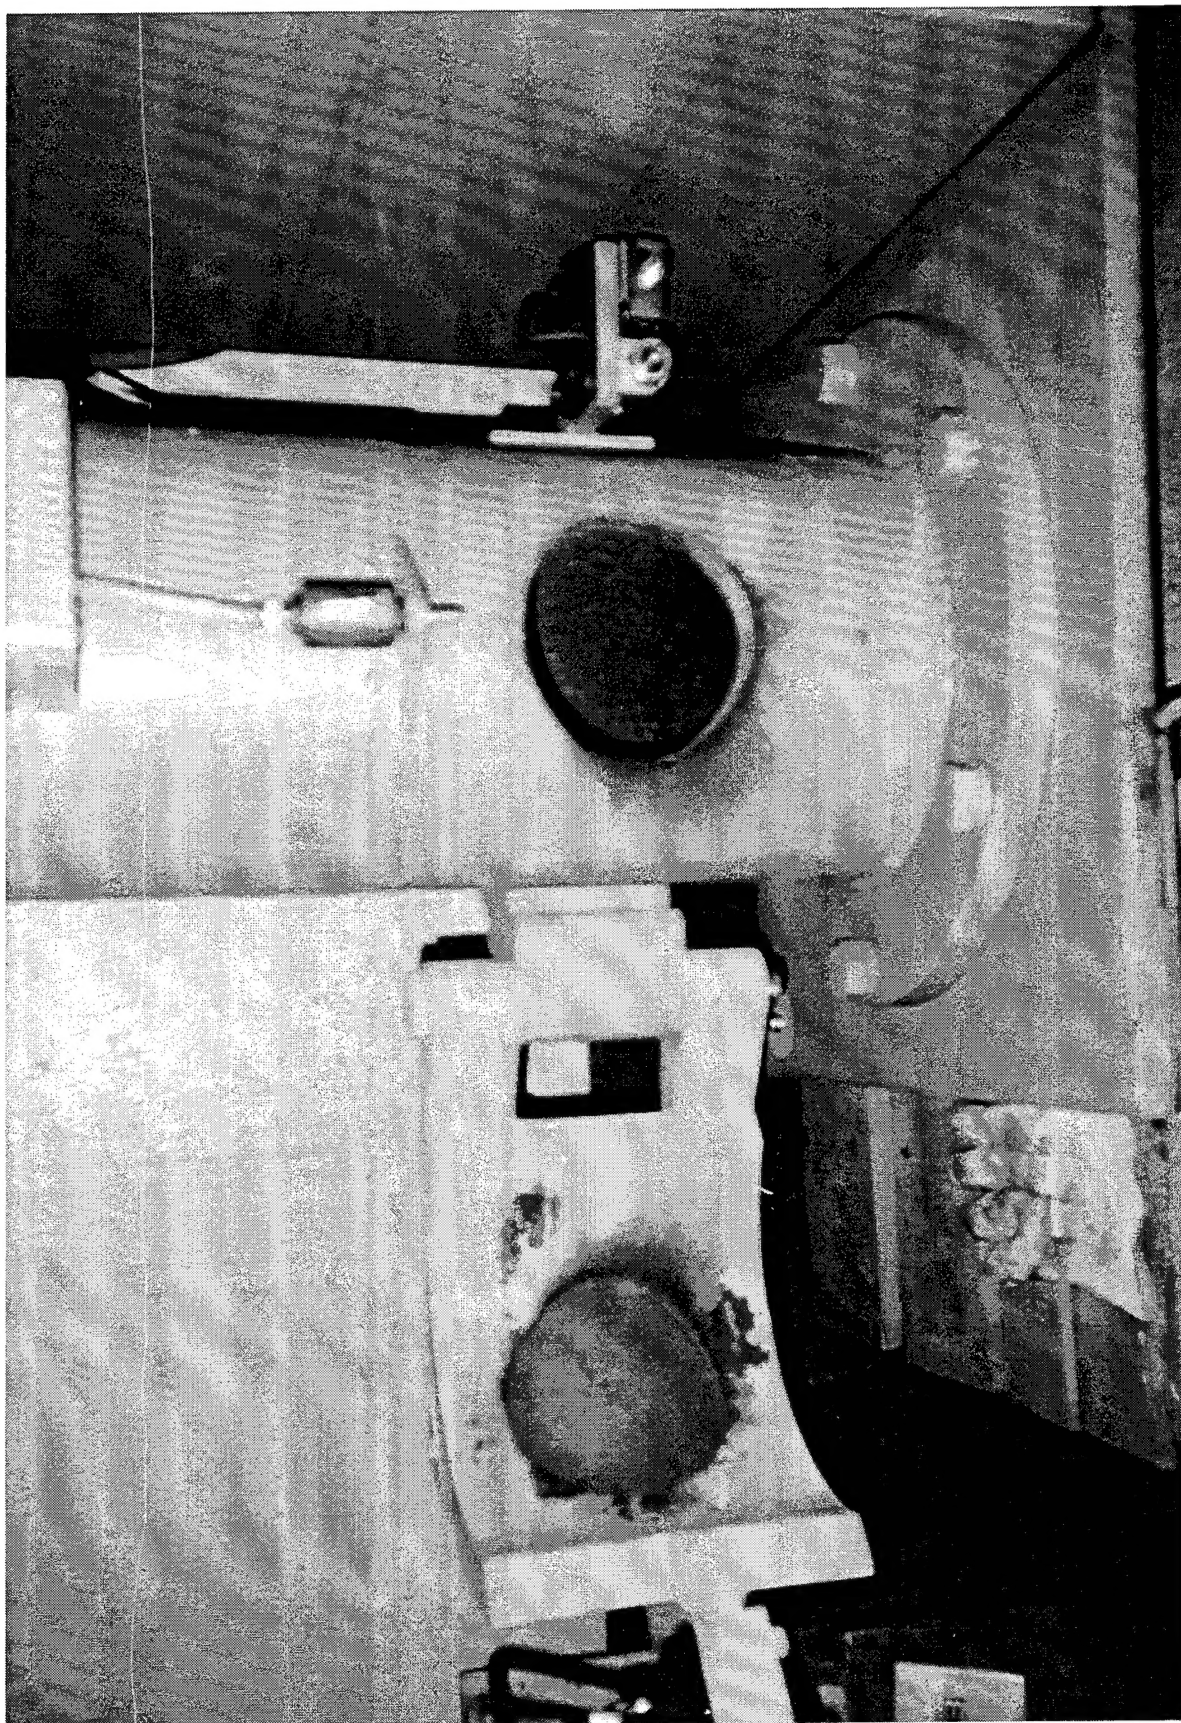
Photo No. USADACS-DEV-96-16-02. This photo shows a closeup view of the APE 1955 modified cleanout door after functioning four grenade fuzes. Note smoke residue on the drop tube and cleanout door. No schrapnel was found outside the drop tube.

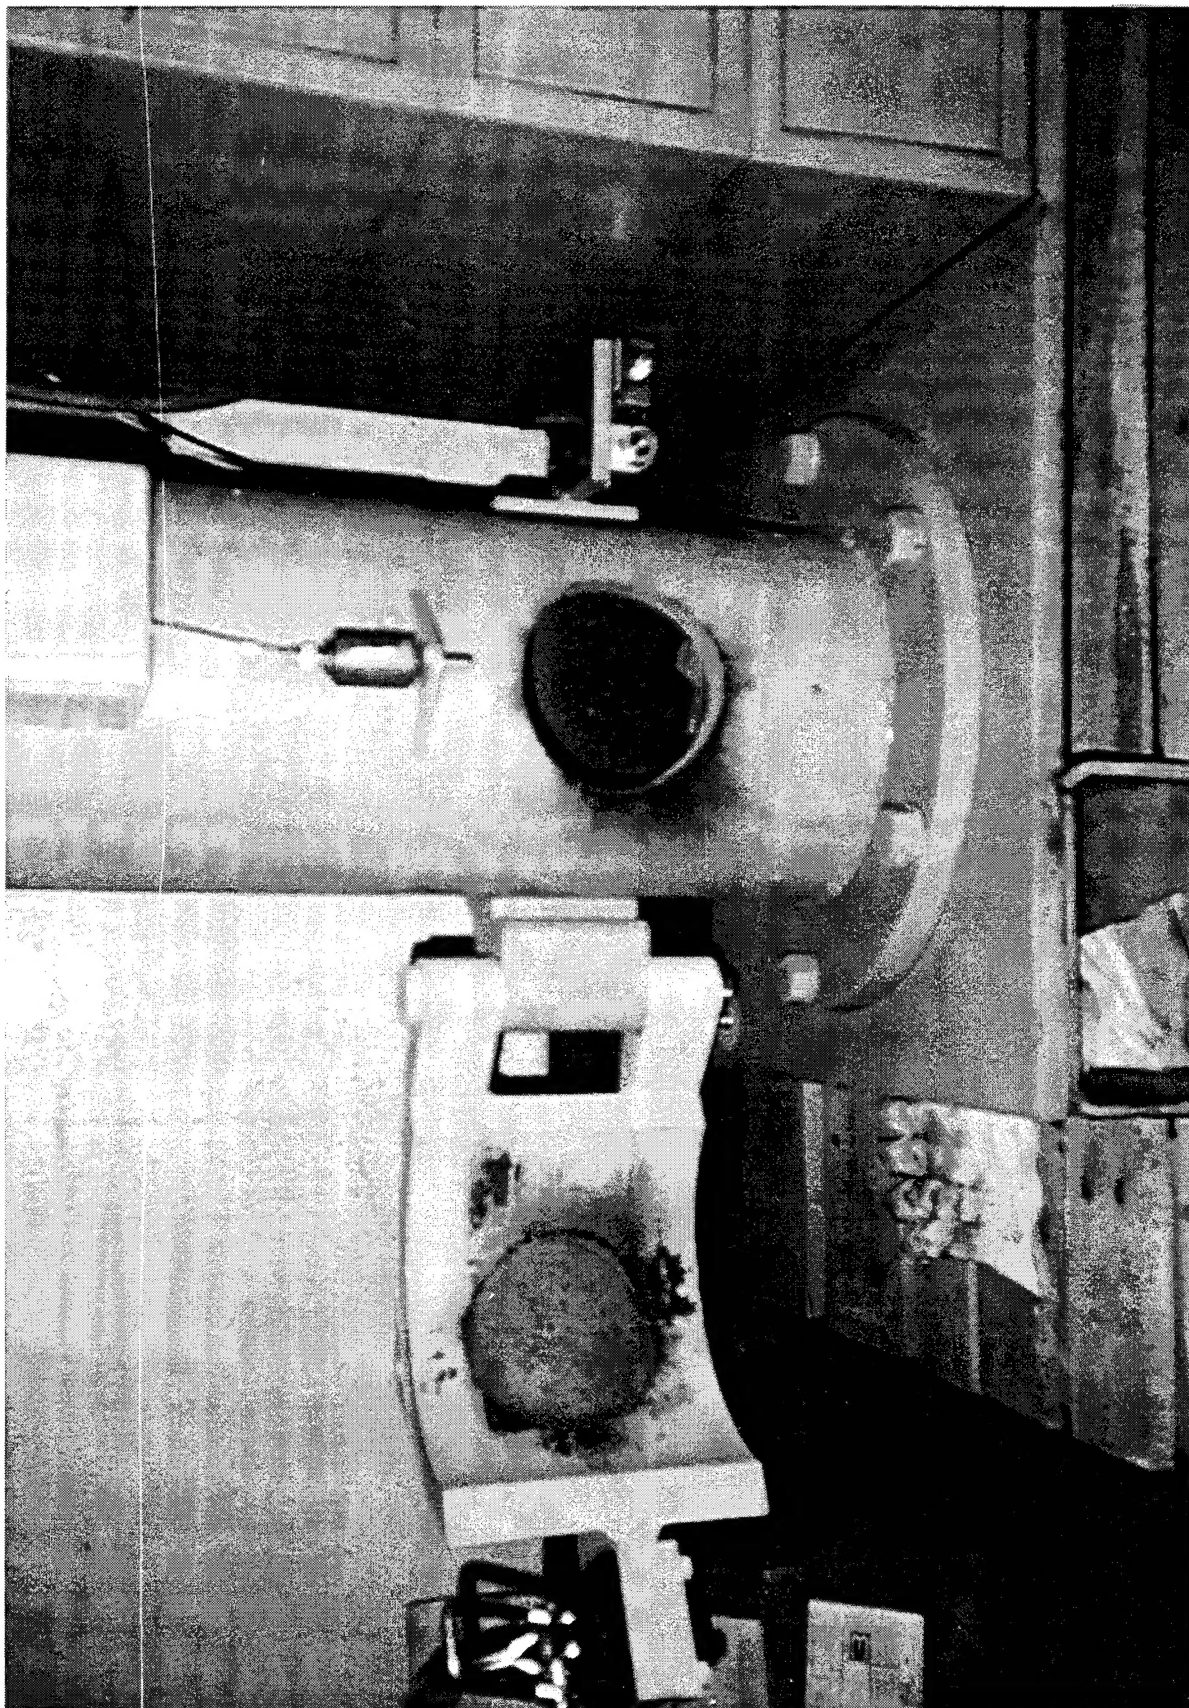
Photo No. USADACS-DEV-96-16-03. This photo shows a closeup view of the APE 1955 modified cleanout door after functioning four grenade fuzes. Note smoke residue on the drop tube and cleanout door. No schrapnel was found outside the drop tube.
